Preservation Management Plan for the Elm Street Cemetery Braintree, Massachusetts Volume I: Report

Prepared for:
The Town of Braintree
Braintree, Massachusetts
February, 2011

Barbara Donohue, RPA

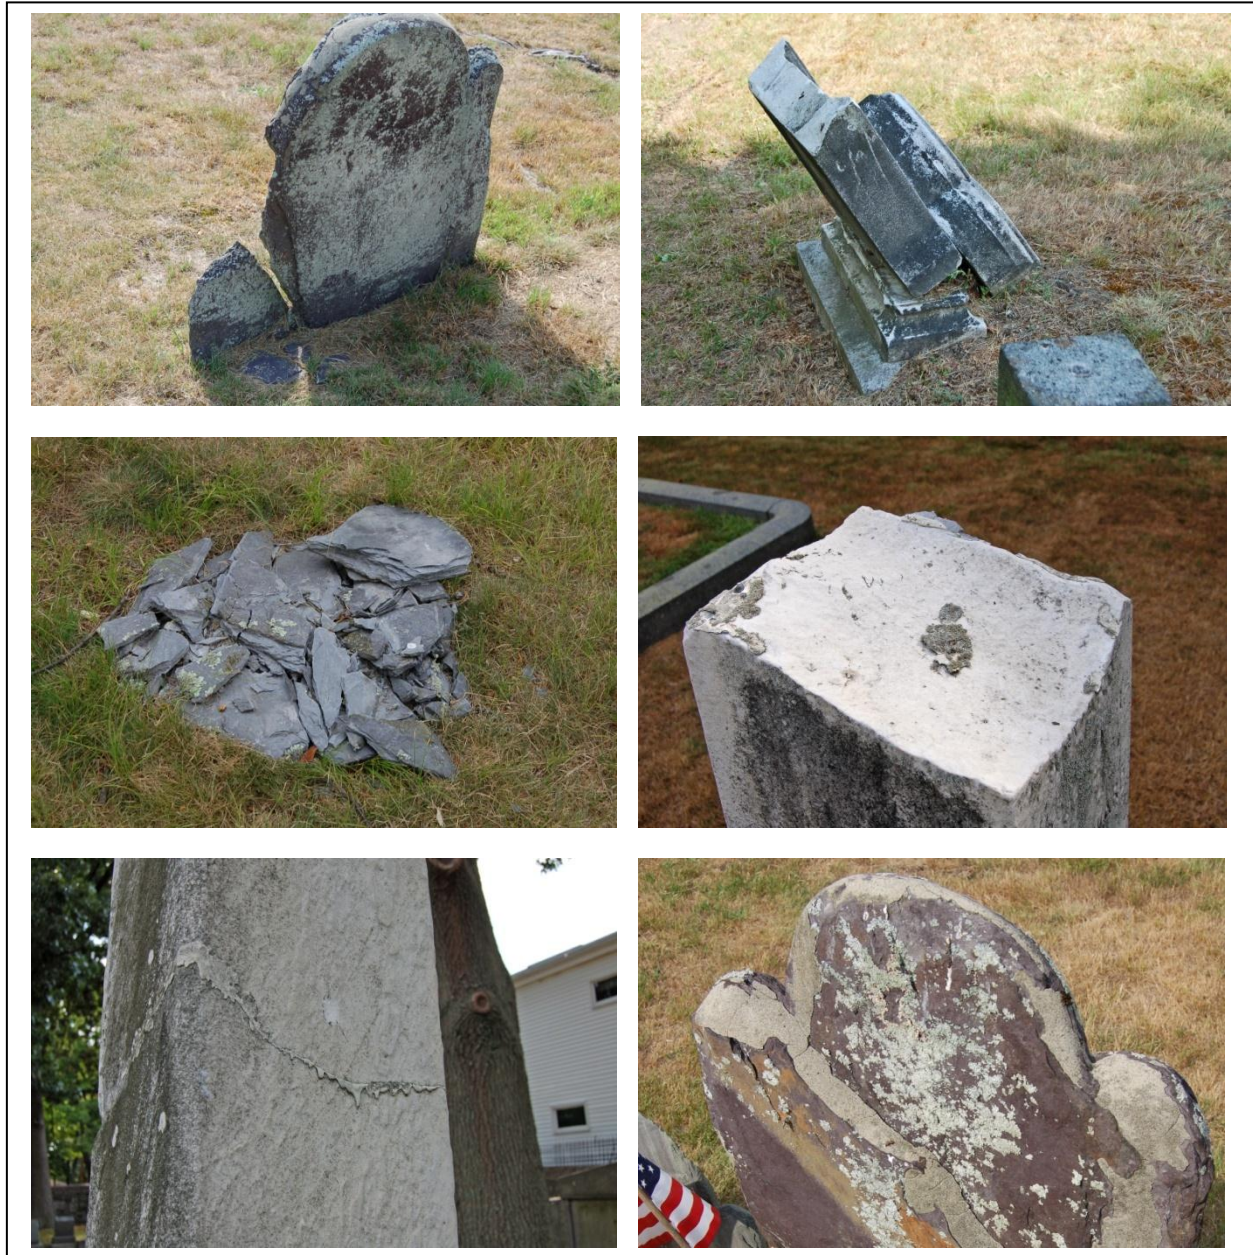
Figure 3-41. Examples of damaged stones requiring professional conservation treatments. Upper left shows a broken slate stone. Upper right is a broken marble stone that also exhibits setting using ferrous pins. Middle row left is a slate stone that fell and was never repaired. Today repair is impossible. Middle row right shows a failed “simple epoxy” repair. Bottom row left shows poor application of epoxy. Bottom row right shows a spalling slate stone that has been repaired using hard Portland cement. This repair is failing as the concrete is beginning to crack and allow water to intrude into the damaged slate, causing additional freeze-thaw damage.

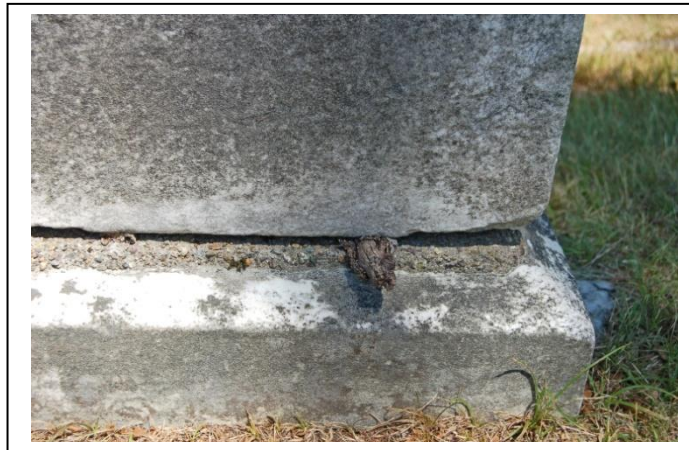
Figure 3-42. Example of a tilted stone that has been improperly “reset” using a branch to prop it up.

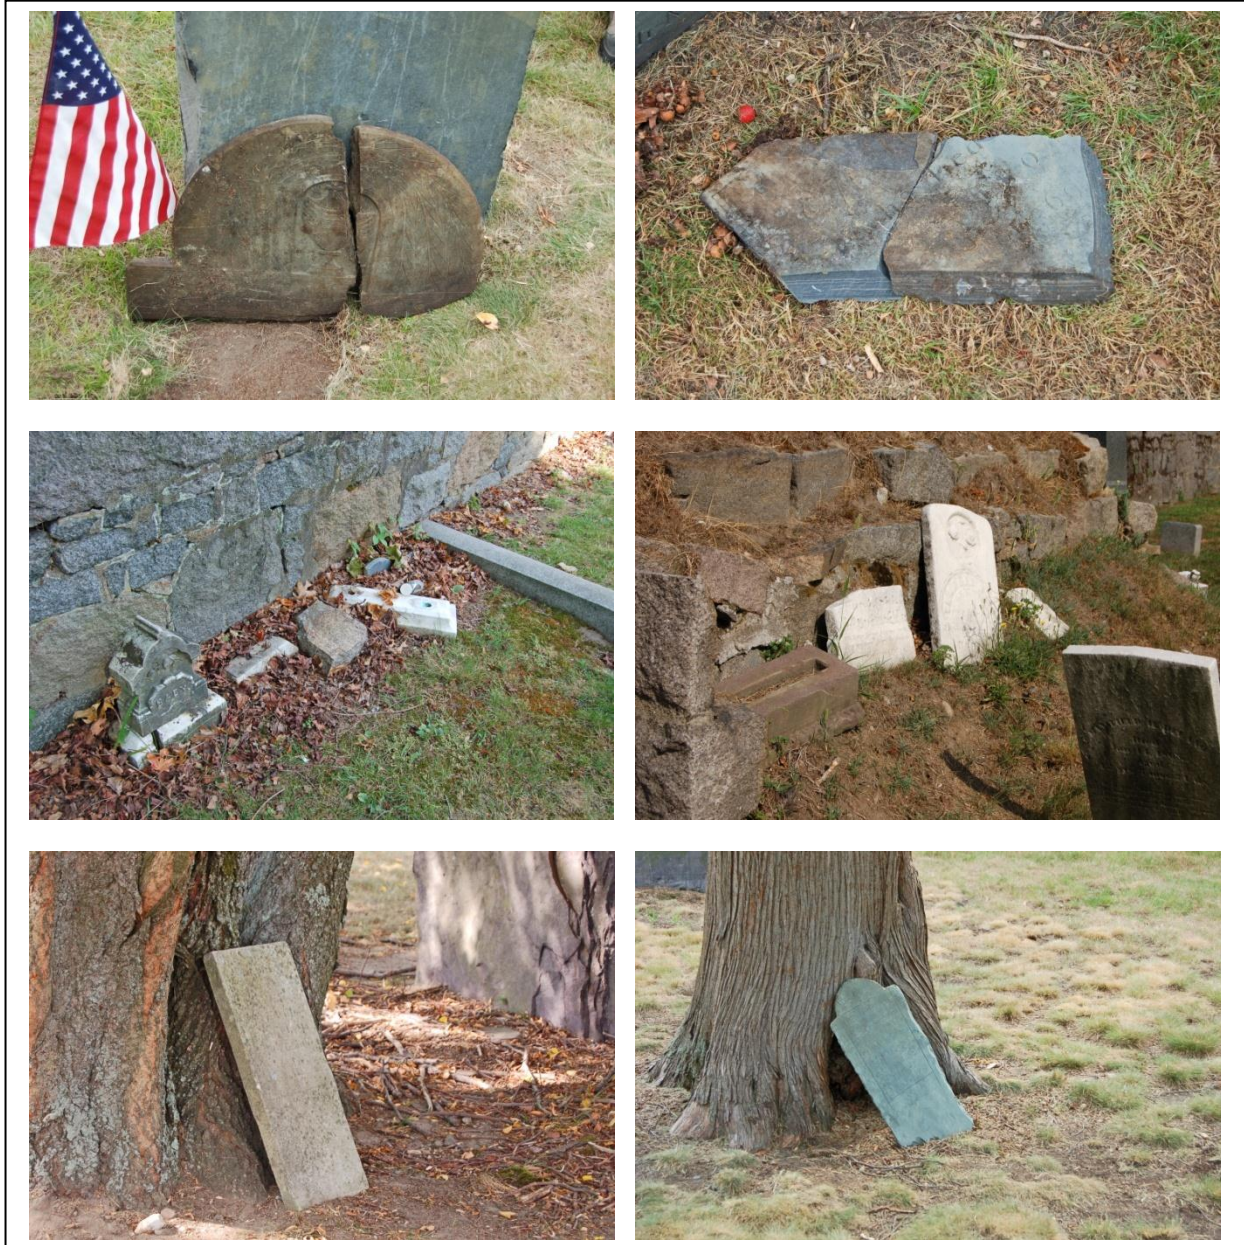
Figure 3-43. Examples of displaced or orphan stones at the Elm Street Cemetery. Top row illustrates slate fragments. Middle row illustrates intact stones with their bases removed from the grave site and “stored” on site – resulting in the loss of the original grave. Bottom row shows two footstones displaced from their associated main stone and leaning against trees.

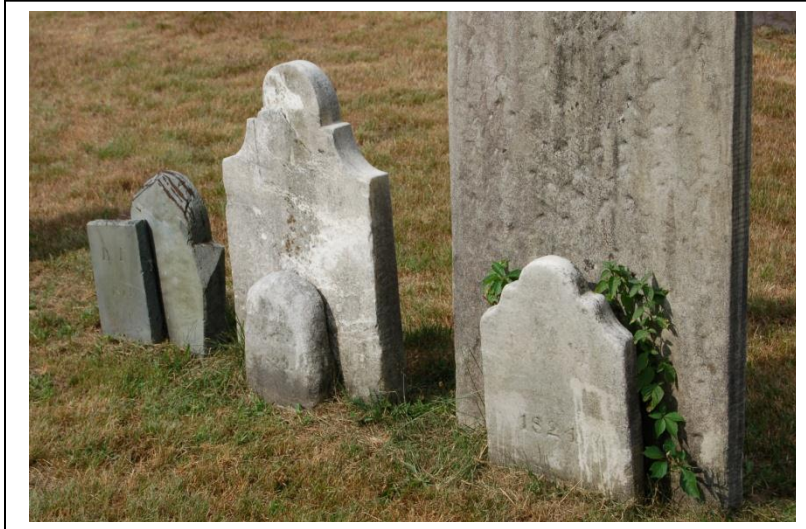
Figure 3-44. Footstones displaced for the convenience of mowing. These footstones should be reset about 5’ behind their respective headstones.

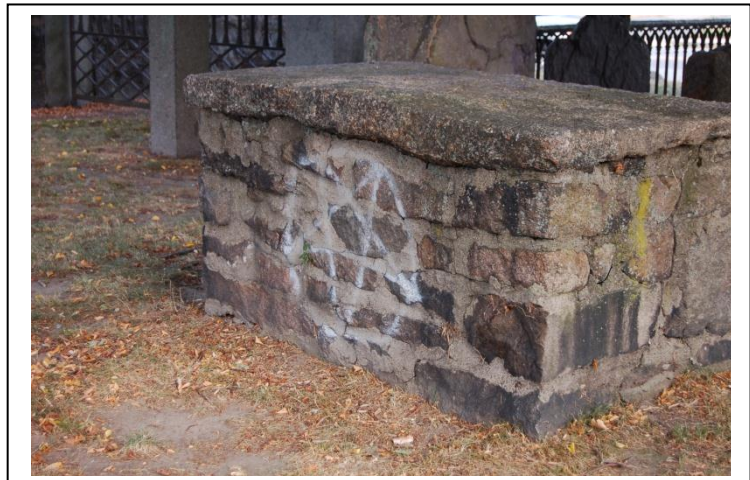
Figure 3-45. Graffiti on the Elizabeth Niles box tomb has been there for over a decade.

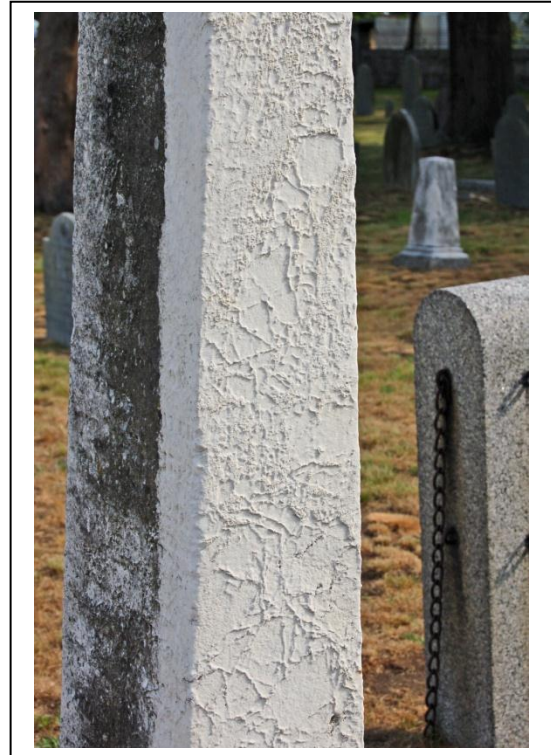
Figure 3-46. Weathering of marble showing the erosion of the stone with veins of harder stone standing “proud.”

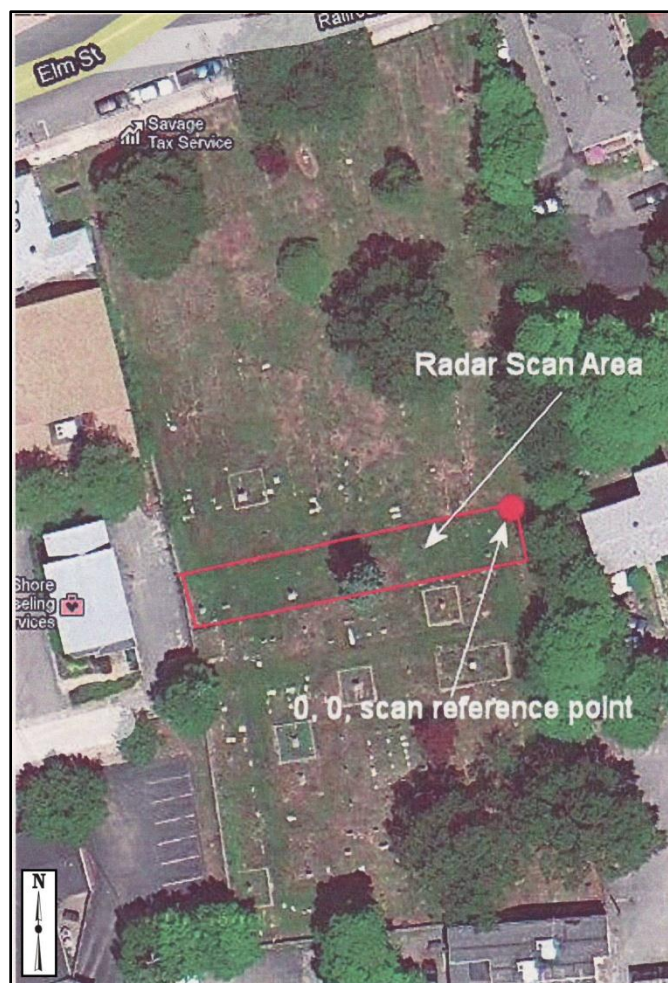
In order to conduct the survey a 146 foot by 26 foot grid was established across the location of the tombs (Figure 4-2). The north baseline (x axis) followed along the series of 15 granite markers that appear as the northern boundary line of the tomb area. Once the north baseline was established several north-south lines (y axis) were placed across the area of the tombs. The radar scan was then plotted and conducted with 1 foot offset transects using GSSU STR-3000 Radar with a 400 Mhz Antenna System, considered the current state-of-the art equipment. The scanning depth (x axis) was to 10 ft (Figure 4-3).

Figure 4-2. Location of the GPR survey on an aerial of the cemetery.

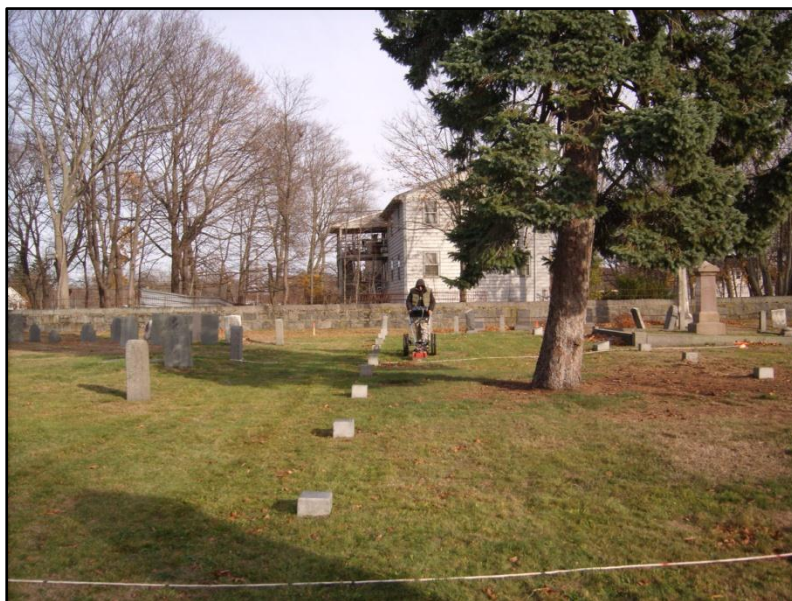
Figure 4-3. Looking east at Mr. Kempton conducting the survey.

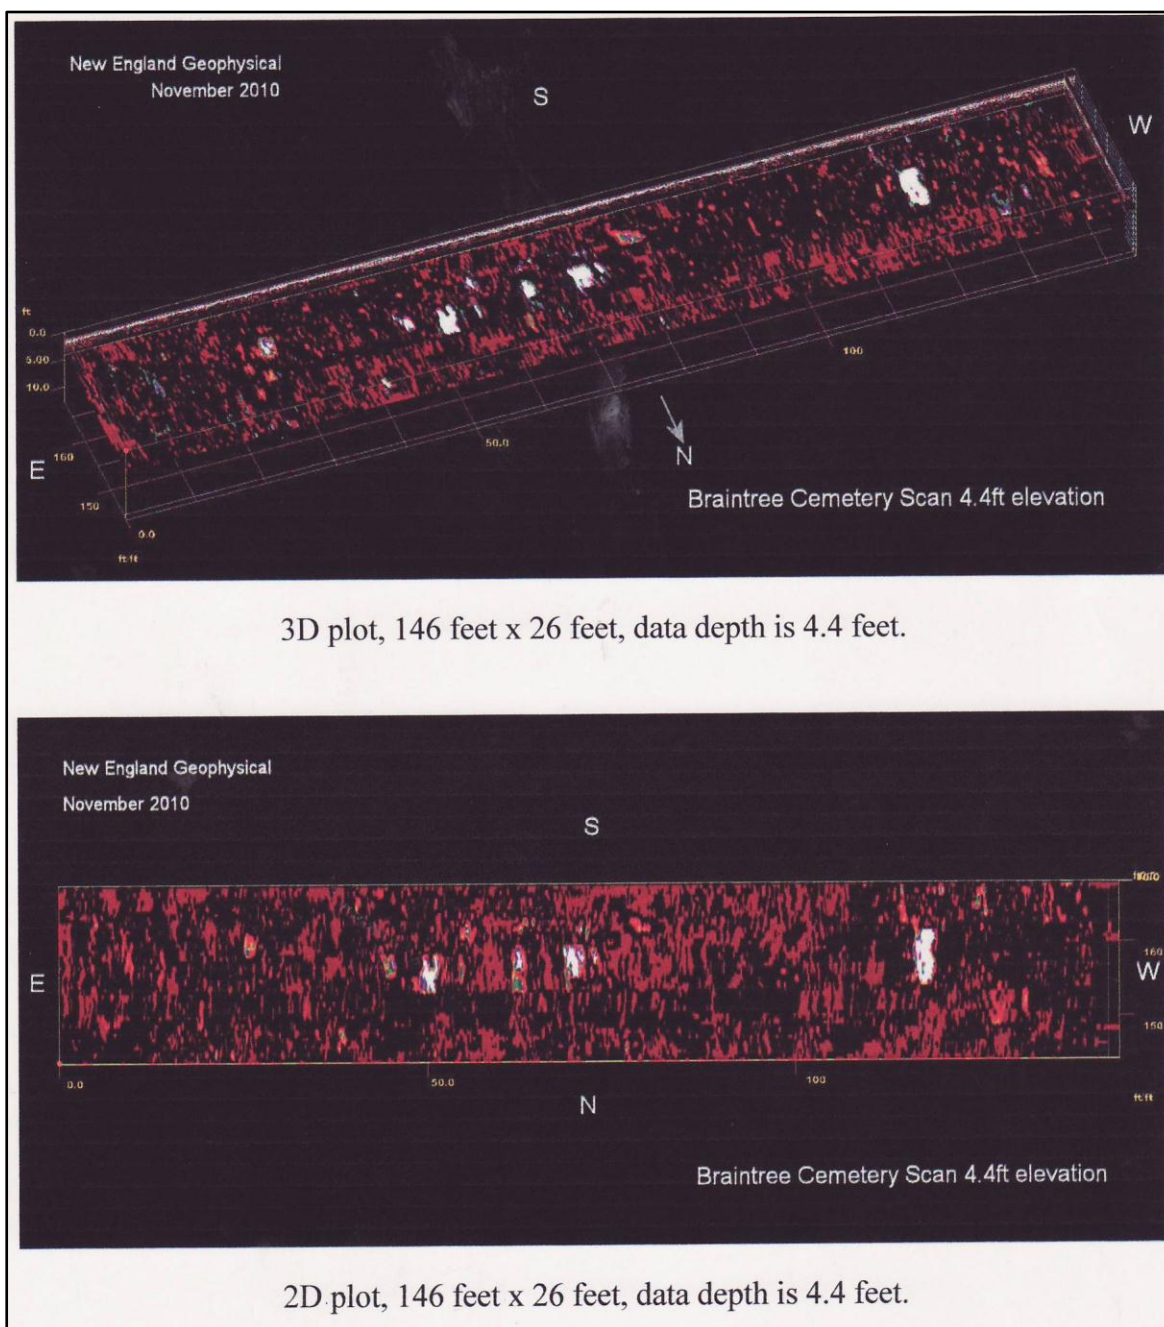
Figure 4-5. Radar images at 4.4 foot depth.

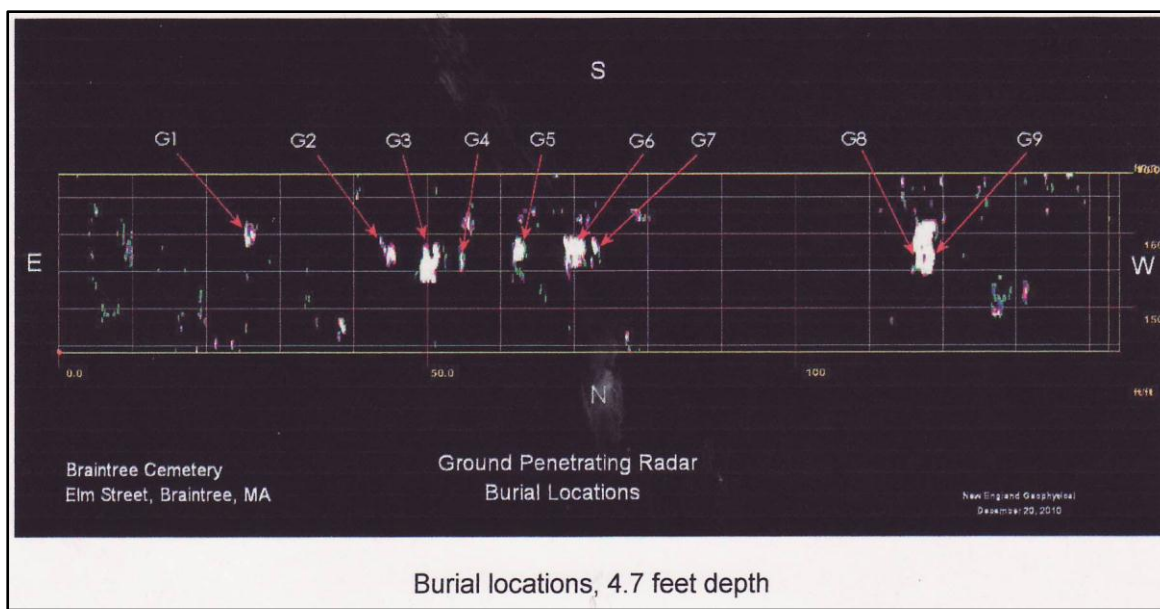
Figure 4-6. Radar images at 4.7 foot depth.

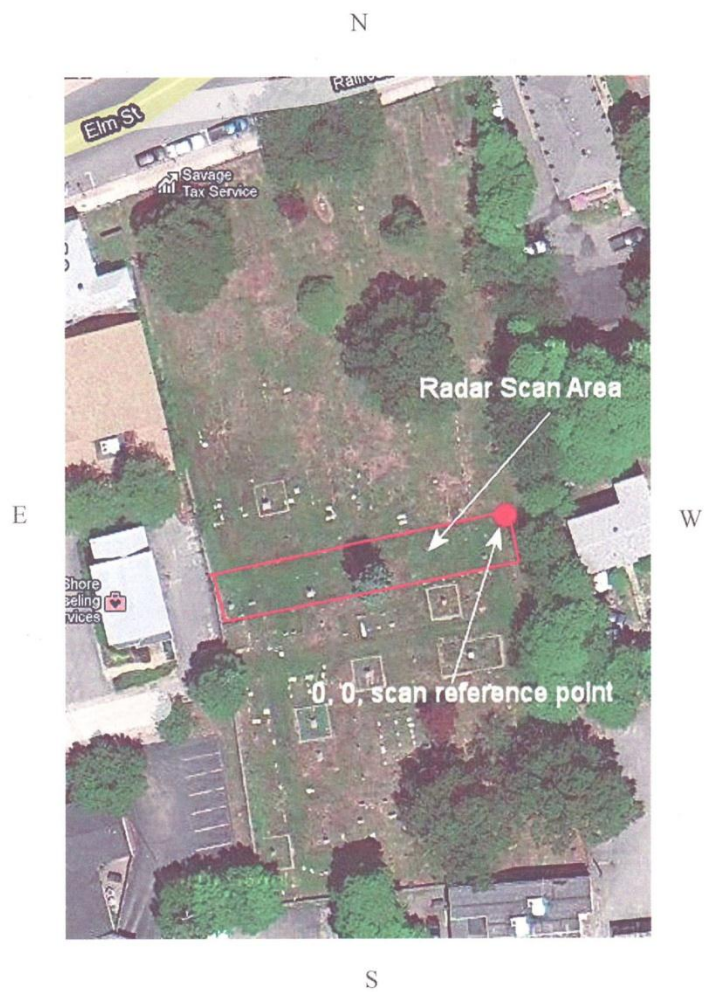
Ground Penetrating Radar Scan Area

Braintree Cemetery
Elm Street
Braintree, Massachusetts
